Manhole Inspection Summary

Manhole # **S29CC_028MH**

Insp Date: **11/19/07 2:38 PM**

Location Address: **501 DOLPHIN ST**

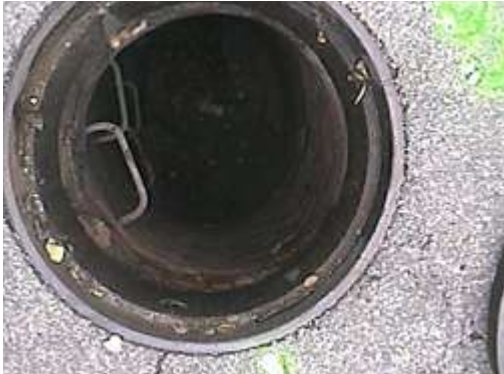
Top View

DEBRIS IN CHANNEL

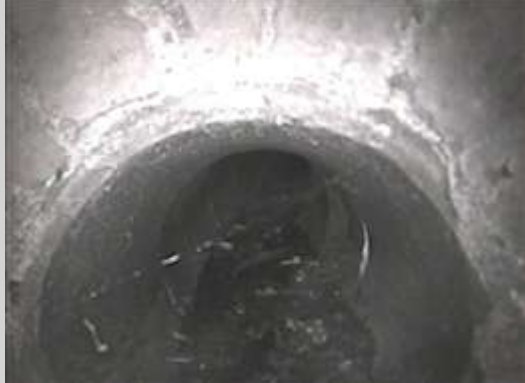
12 O'Clock Outflow

8 in. Circular Gravity Sewer
Pipe Out @ 12 O'Clock

Deposits: ☐ None ☐ Mud ☐ Sludge ☒ **Debris** ☐ Grease

Silt Depth: **4** (in.) Deposits Extent: **Medium**
